Elevations			
Dwg: Dave F.	Date: 26 Dec 05

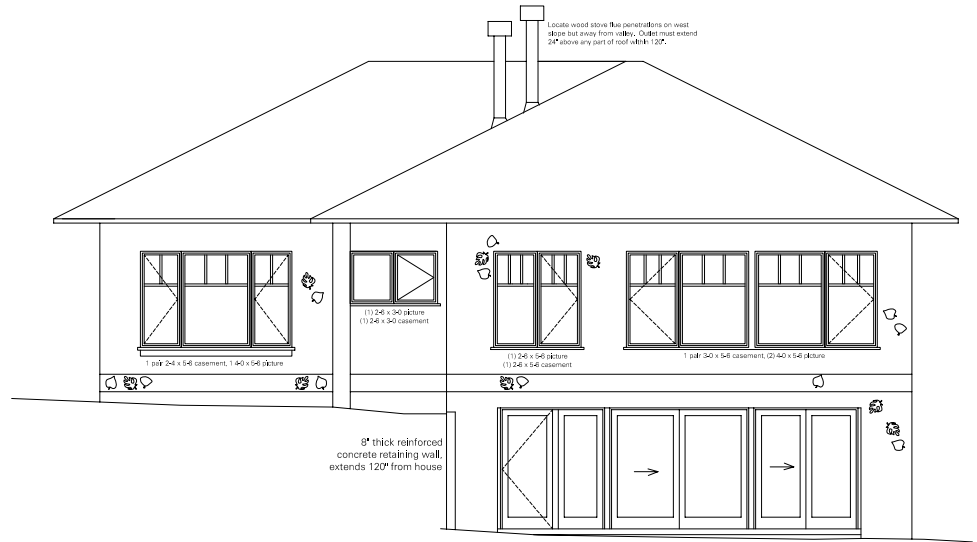
South elevation

3-0/7-0 glass LH, fixed right, 6-0/7-0 6 6-0/7-0 insulated sliding glass doors
